CALSPAN AIR BAG DEPLOYMENT INVESTIGATION

CALSPAN CASE NO. CA96-11

**VEHICLE #1 - 1995 FORD CONTOUR
VEHICLE #2 - 1994 LINCOLN TOWN CAR**

LOCATION - STATE OF PENNSYLVANIA

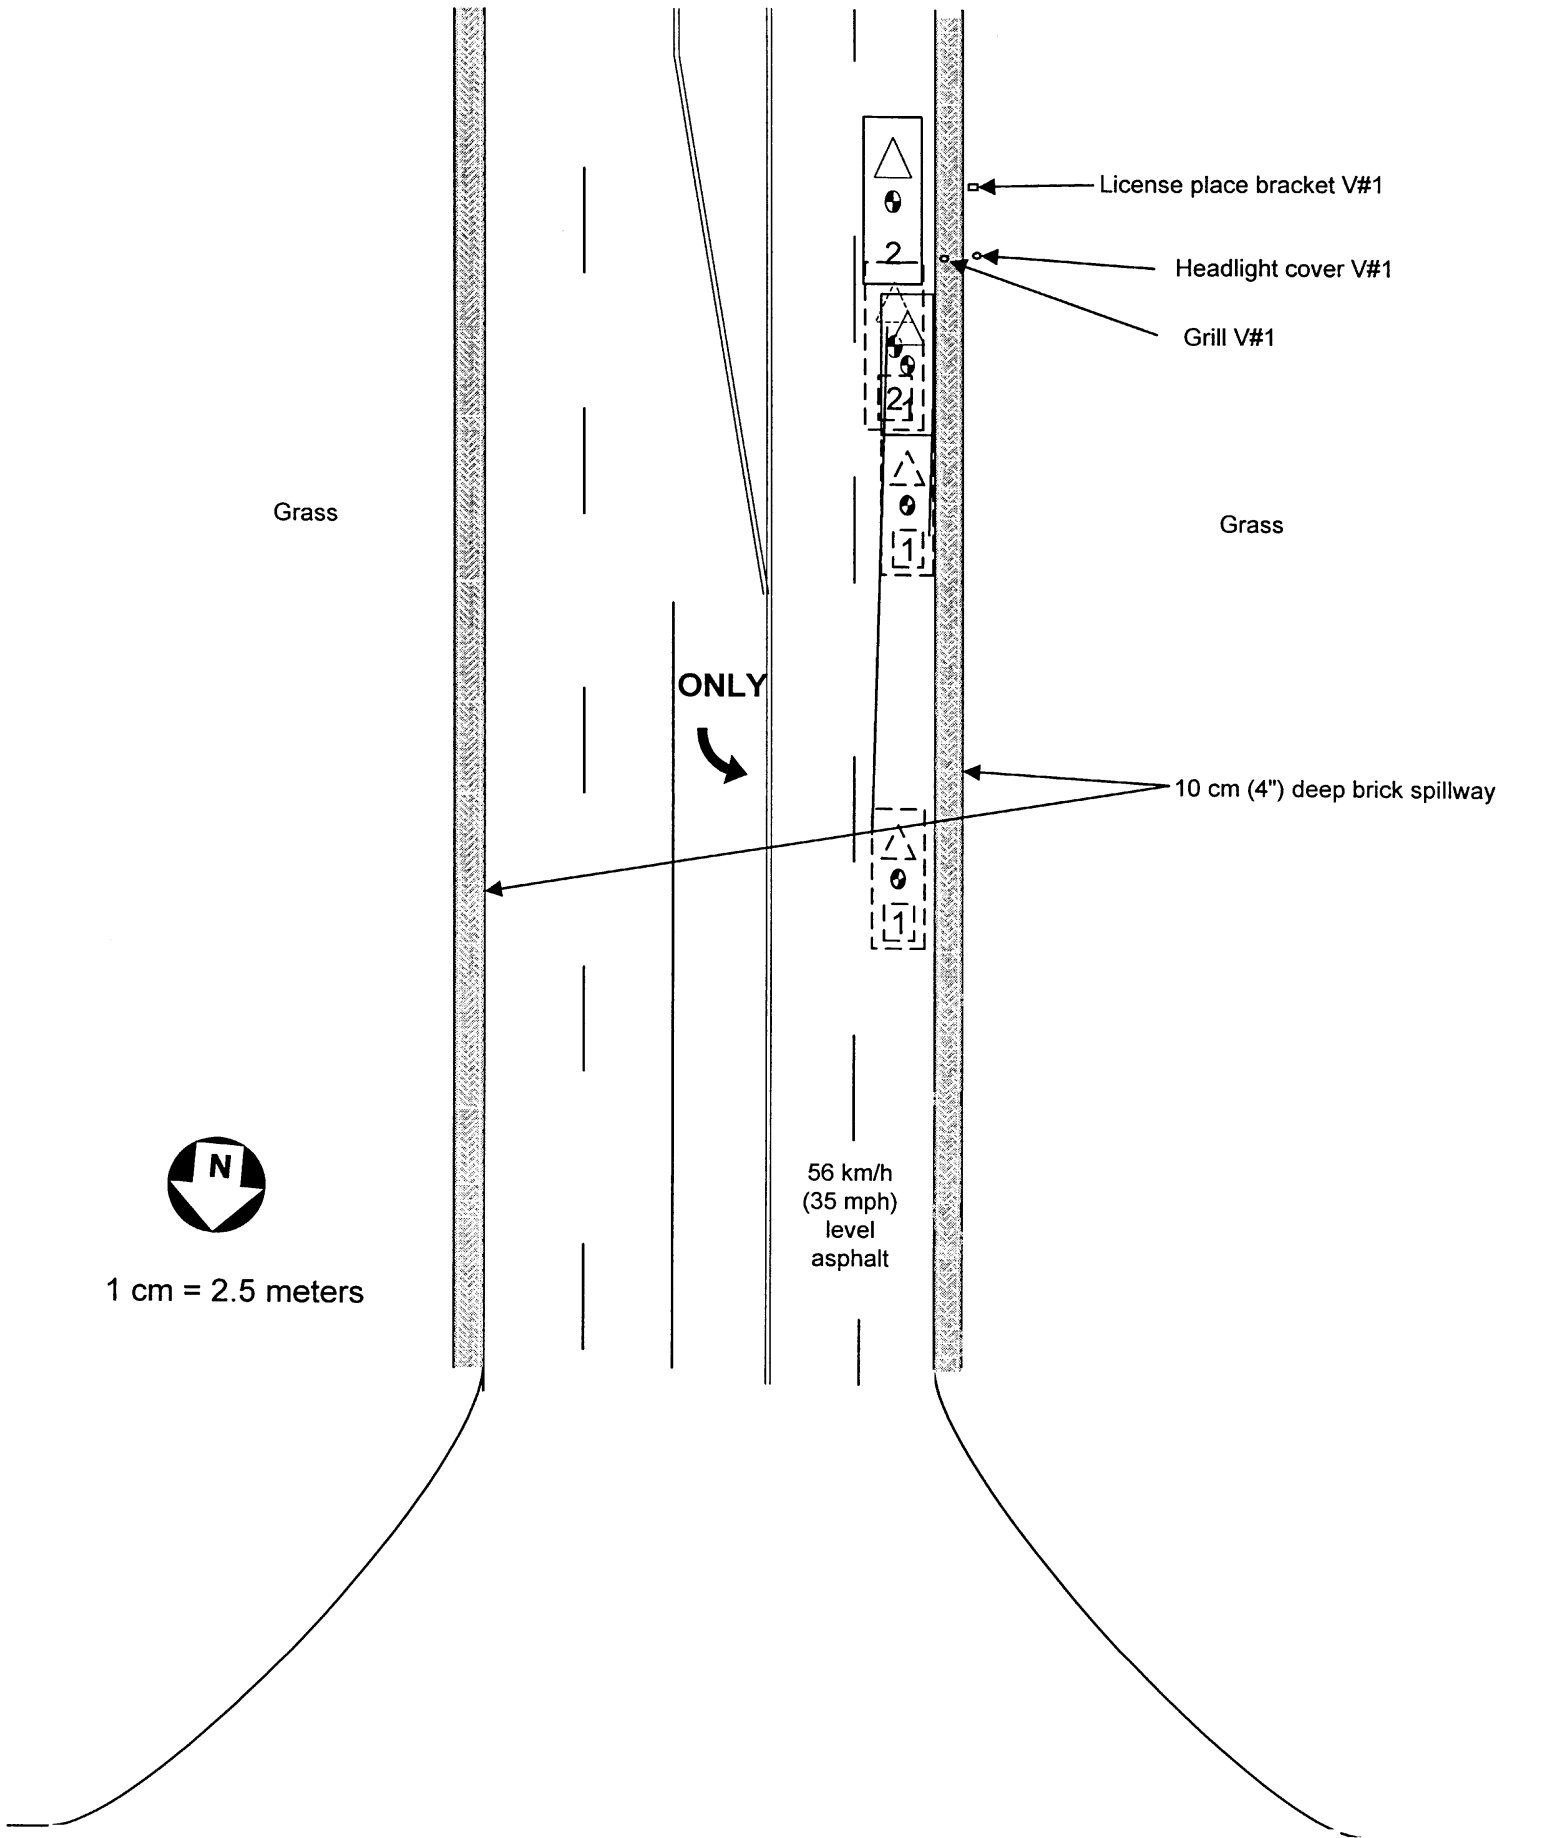
CRASH SCENE SCHEMATIC
Calspan Case CA96-11

A two vehicle front to rear crash involved a 1995 Ford Contour GL (Vehicle #1) equipped with dual front air bags and a 1994 Lincoln Continental (Vehicle #2). The crash occurred on a four lane, urban, straight, undivided, dry, level, asphalt roadway surface which was located 12.2 meters (40 ft.) south of a four leg intersection. There were no adverse weather conditions.

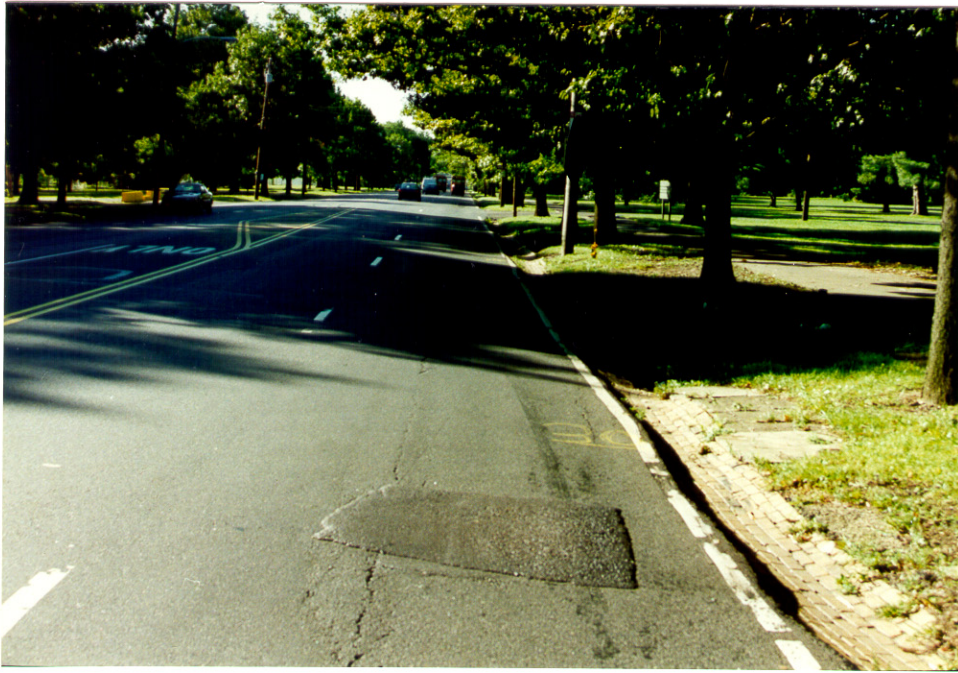
2. View of the pre-crash trajectory from the four-leg intersection.

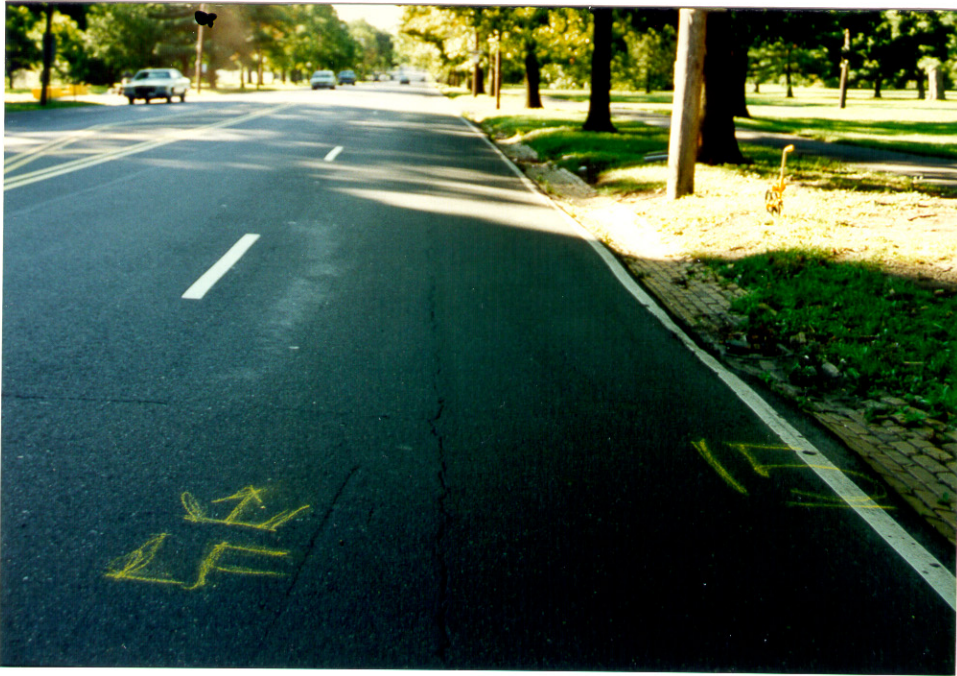
4. Pre-crash trajectory - 30 meters (98 ft.) prior to the point of impact (POI).

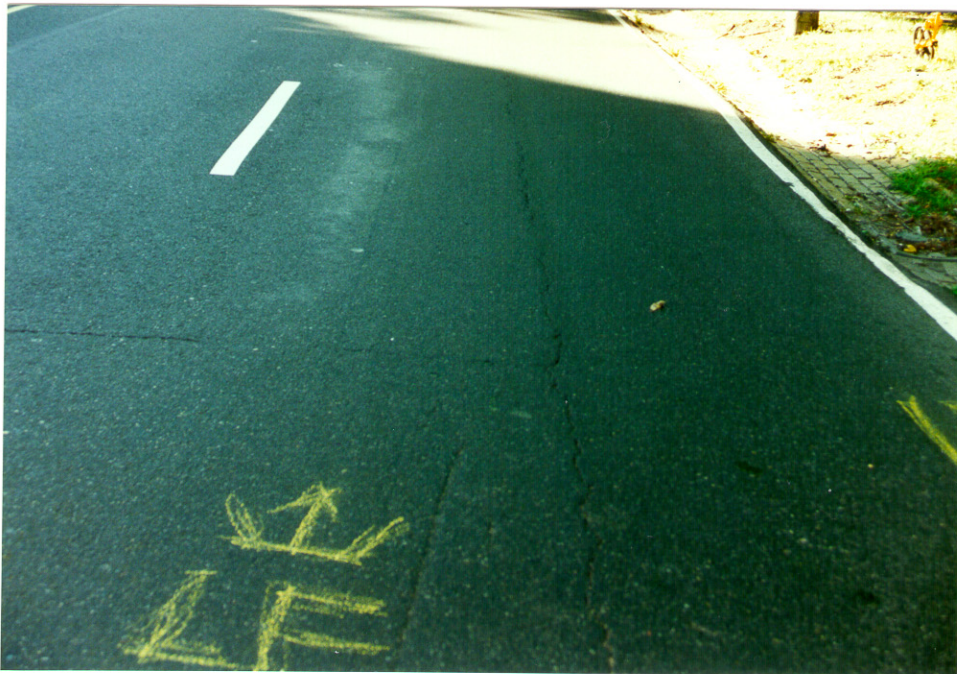
5. Pre-crash trajectory -15 meters (49 ft.) from POI.

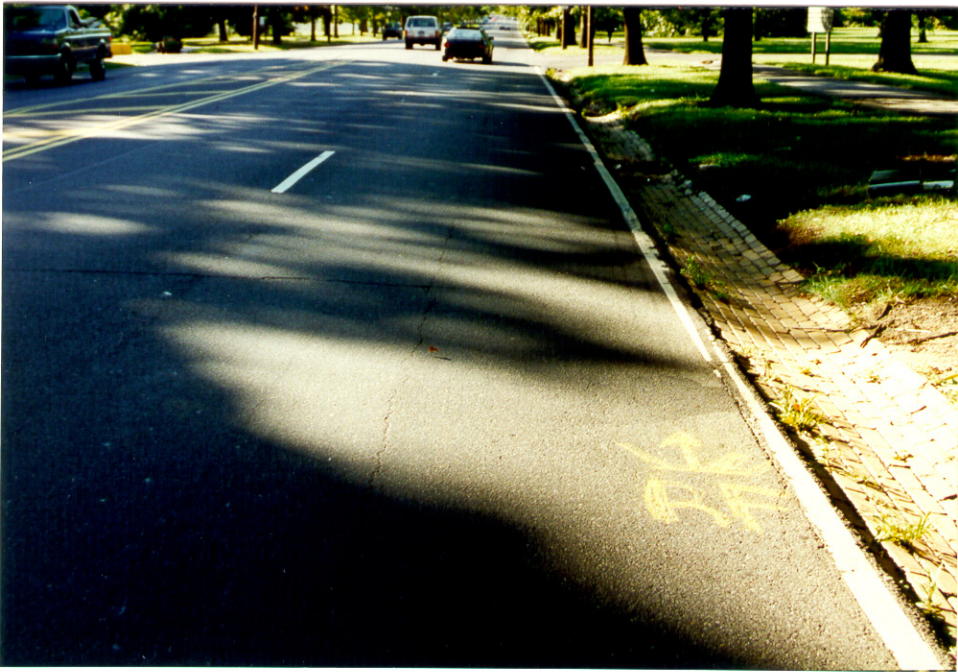
6. View showing the start of the left front skid mark prior to impact.

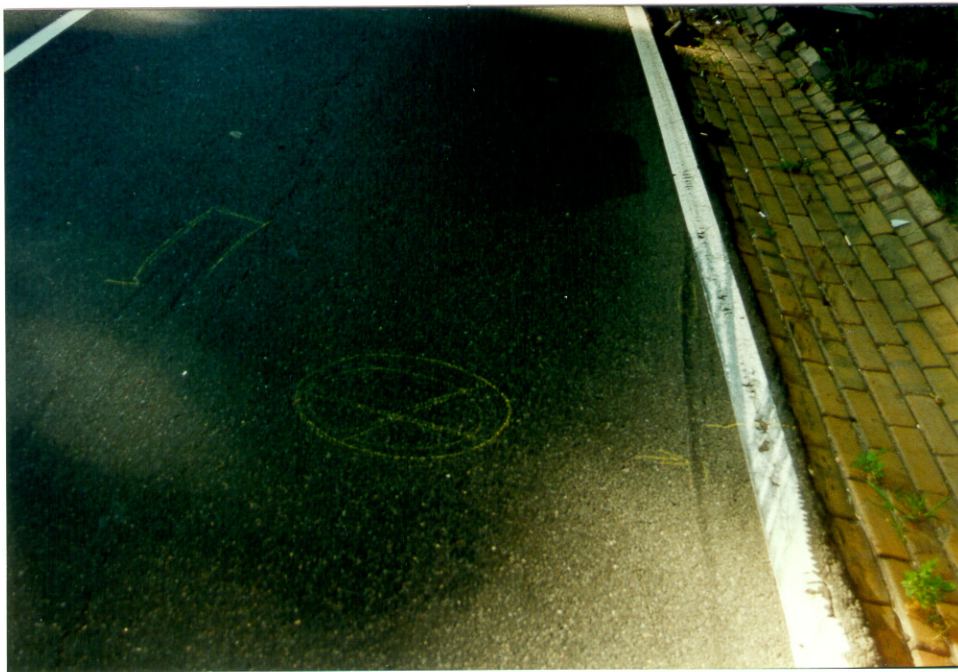
9. View of the point of impact.

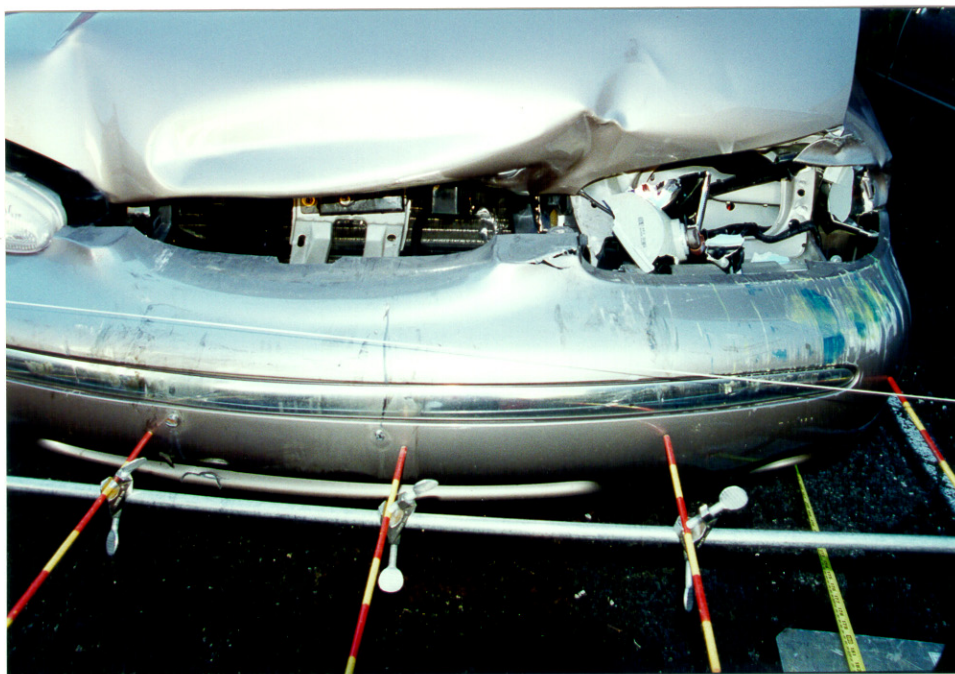
The frontal plane of the 1995 Ford Contour (Vehicle #1) struck the rear plane of the 1994 Lincoln Town Car (Vehicle #2). The damage profile represented a typical bumper override/underride contact pattern. Vehicle #1 sustained direct contact damage across the left front bumper and hood area. The front bumper sustained a maximum rearward displacement of 3.0 cm (1.2") and the hood area displaced a maximum rearward displacement of 21 cm (8.3"). The upper radiator support panel was displaced rearward a maximum of 10.0 cm (3.9"). Crush values obtained are listed below:

15. Overall view of the frontal plane of the 1995 Ford Contour GL (Vehicle #1).

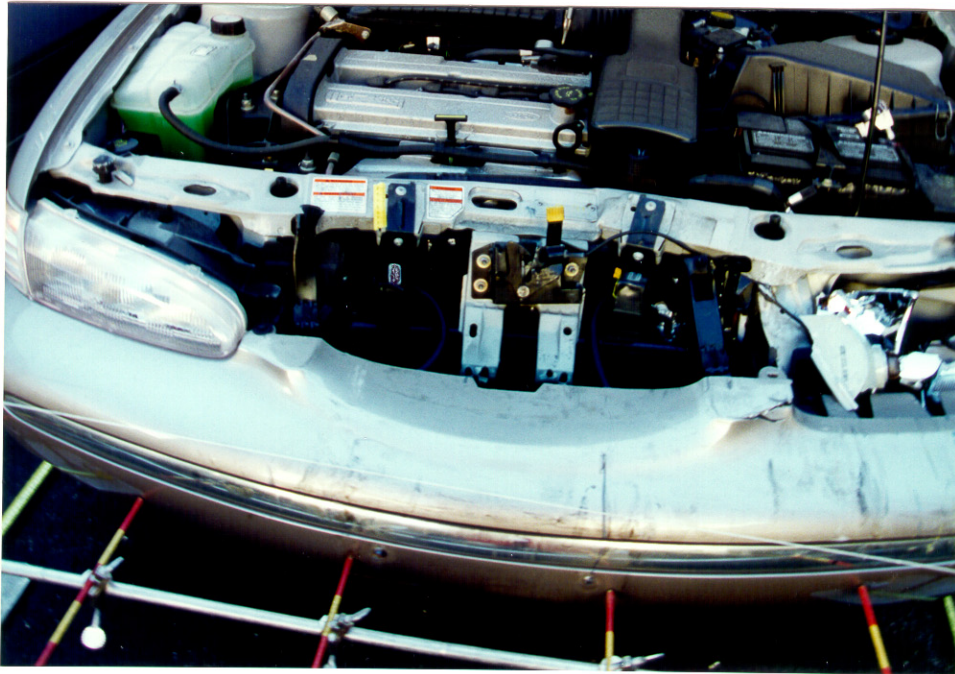
Components damaged in the crash included the front bumper fascia, the grille, the left headlight and directional light assembly, the hood, the left fender, the radiator, and the windshield.

16. View of the direct contact damage to the center and left frontal plane.

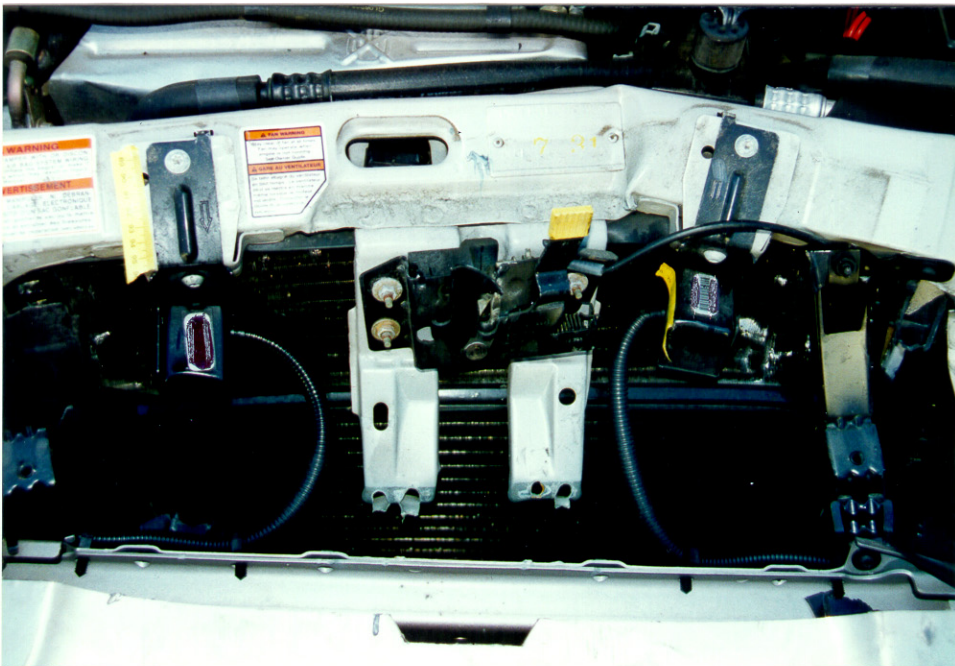
17. View of the damage to the upper radiator support bracket and crash sensors located on the upper radiator support bracket.

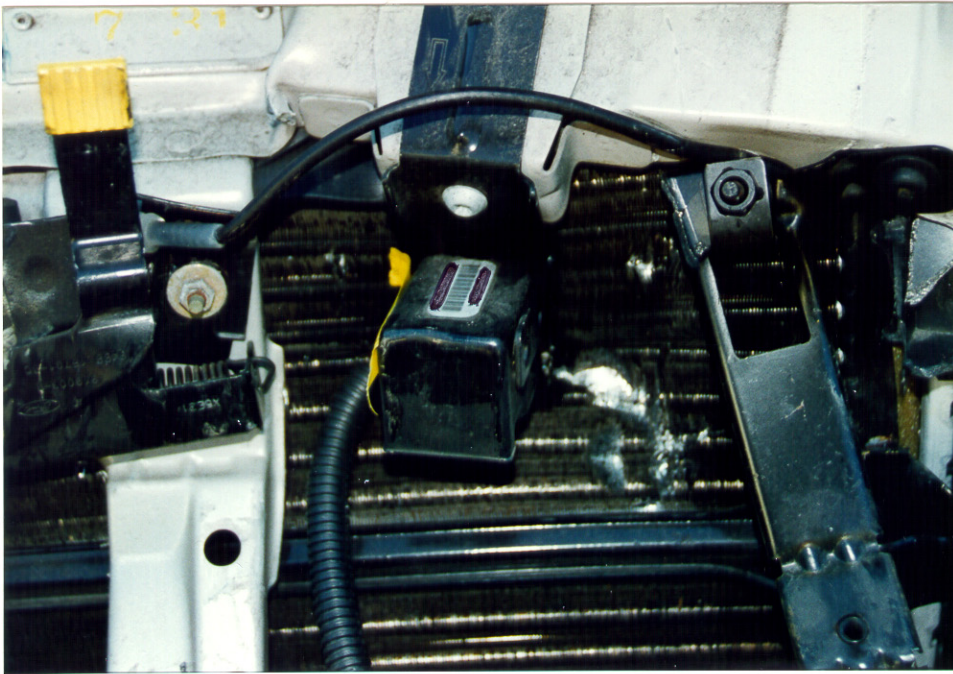
18. Close-up view of the crash sensors.

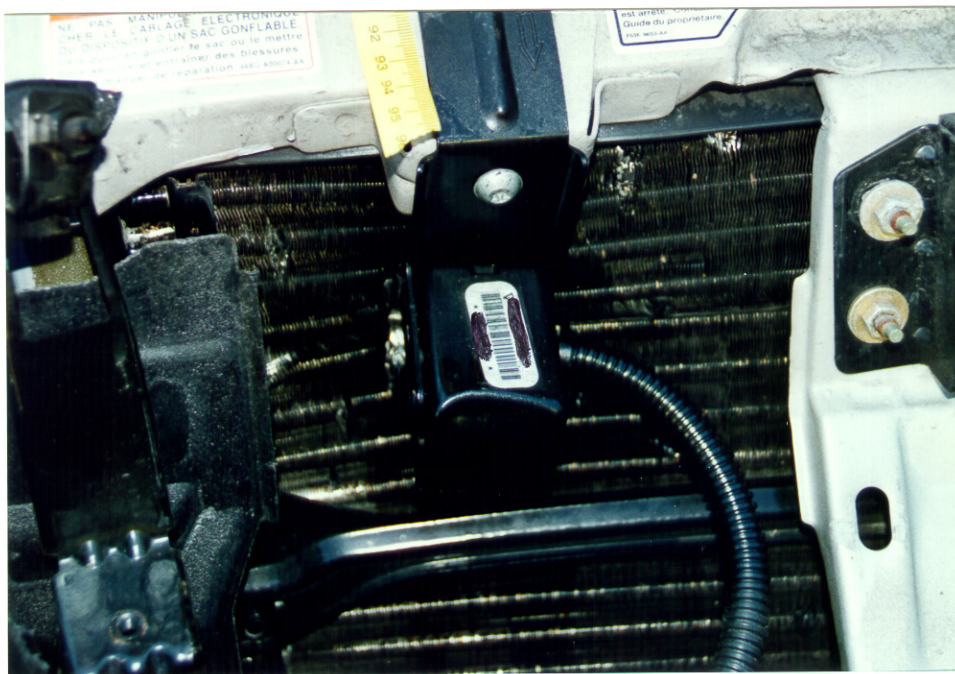
19. Close-up view of the damage to the left crash sensor.

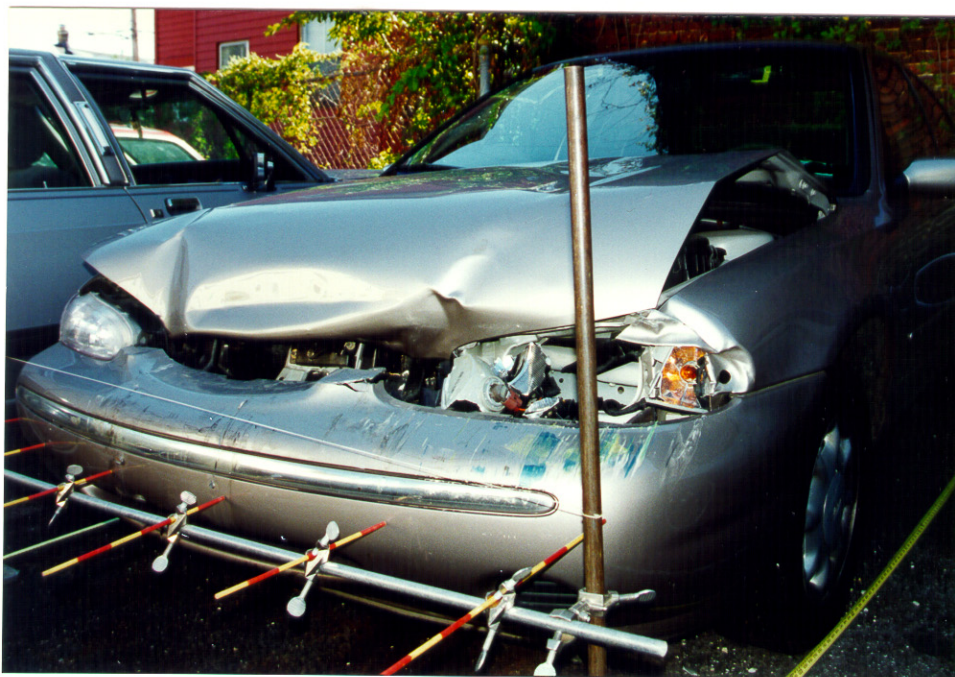
20. Close-up view of the damage to the right crash sensor.

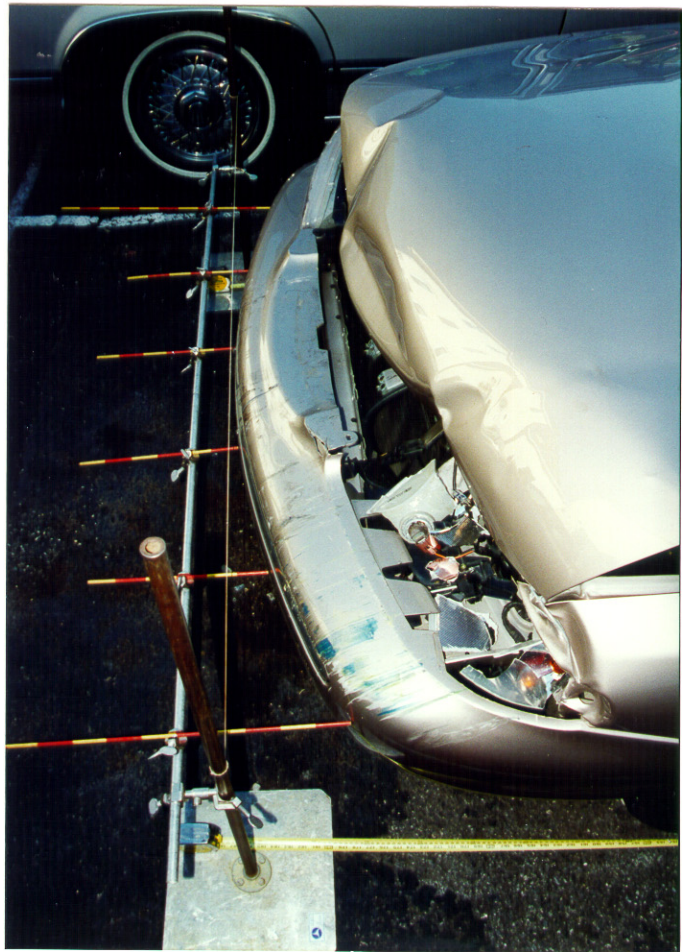
23. Overhead view of the frontal plane showing rearward deformation.

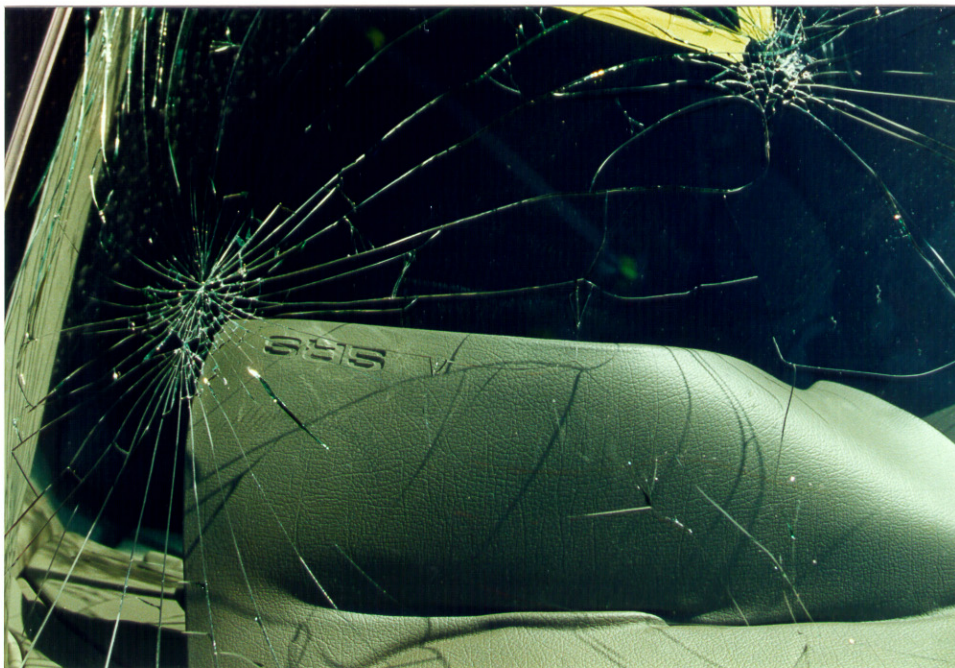
The windshield exhibited four glazing fractures. The first fracture had a spider web configuration which was attributed to contact by the driver's left hand. This crack was located 16.5 cm (6.5") below the header and 35.6 cm (14.0") left of the vehicle centerline. The second windshield fracture was located 24.8 cm (9.75") right of center and 34.3 cm (13.5") below the header. The pattern of the fracture did not have a focal point normally associated with occupant contact or edge loading by the air bag module cover. This fracture was attributed to loading by the expanding passenger side air bag against the windshield during deployment.

31. Close-up view of the contact evidence on the windshield.

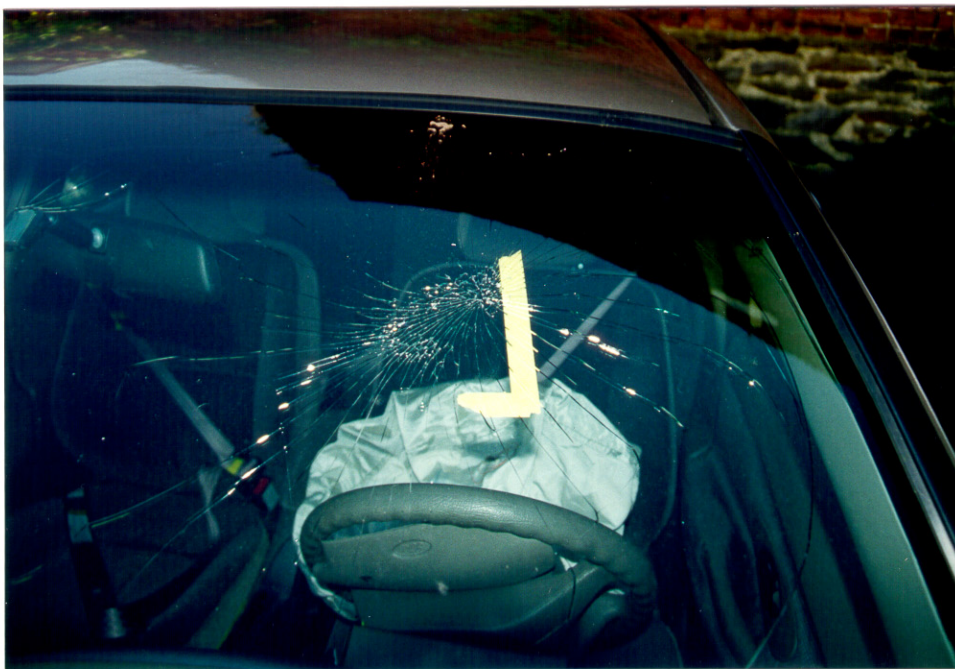
32. View of the windshield contact damage with respect to the air bag module cover.

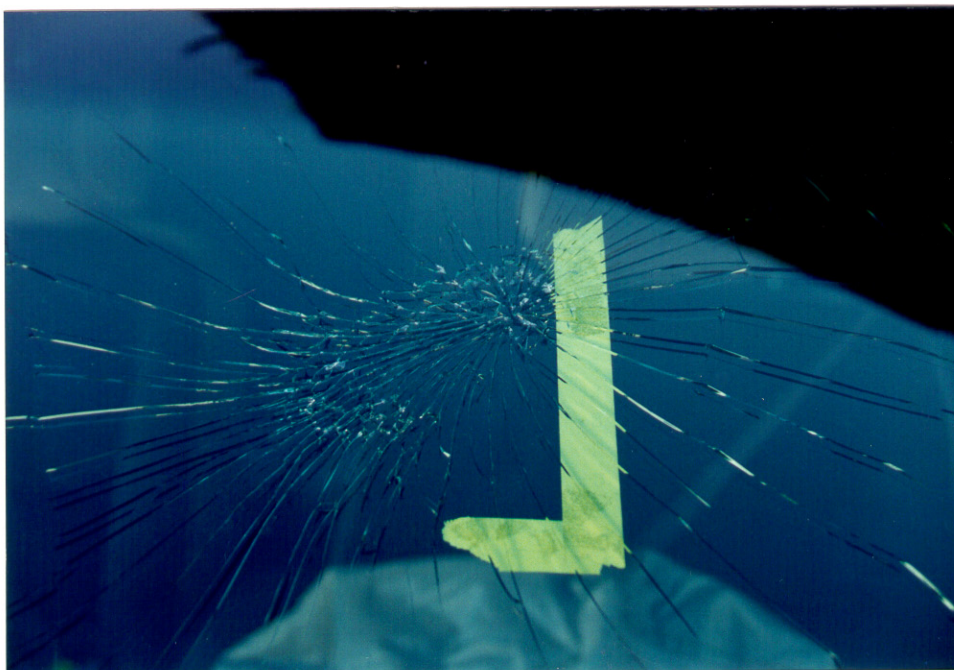
The driver's left hand was displaced from the steering wheel rim by the expanding air bag and contacted the windshield which resulted in a typical spider web fracture pattern. This fracture was located 16.5 cm (6.5") below the header and 35.6 cm (14.0") left of the vehicle centerline.

33. View of the driver's side windshield damage.

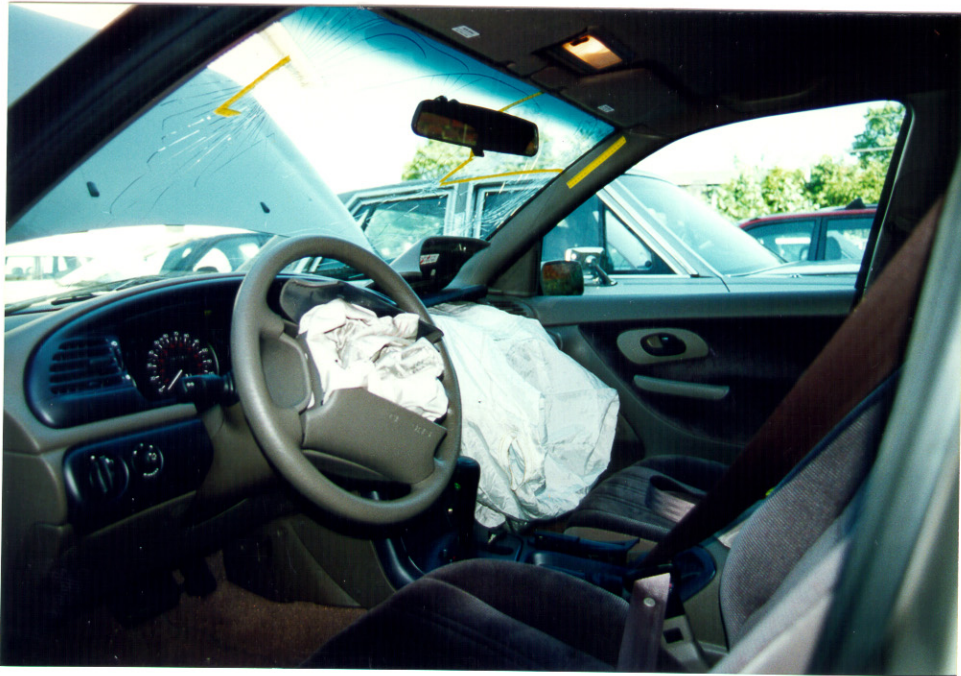
34. Close-up view of the windshield damage.

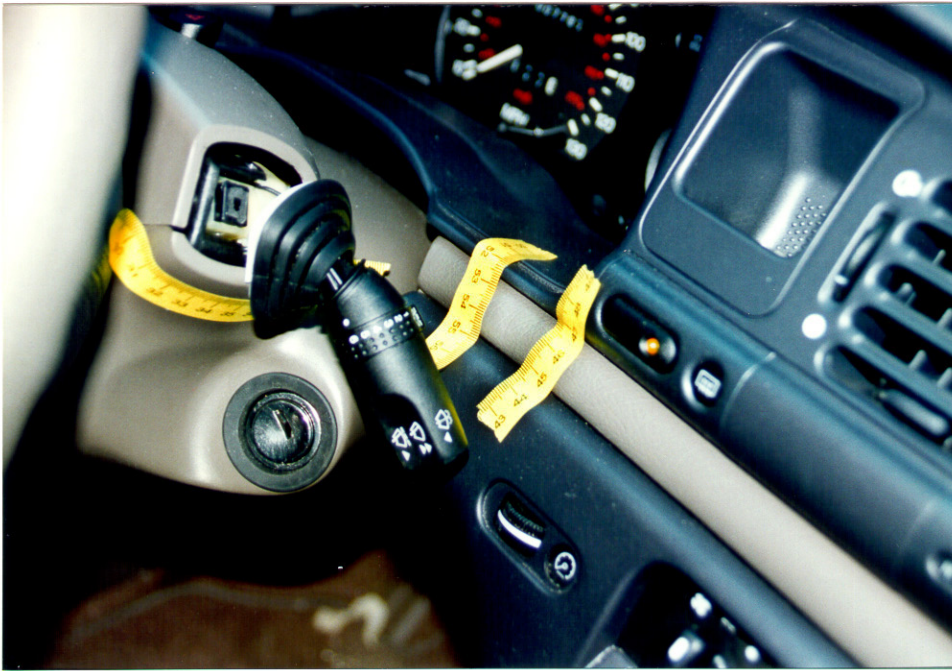
The windshield wiper control arm located on the right side of the steering column was broken as a result of contact by the right hand of the driver during the crash. A transfer mark located on the instrument panel forward of the wiper control arm was associated with the driver's right hand as it continued to move forward in response to impact forces (refer to photograph #43 on page A-22).

43. Deformation of the wiper control arm located on the right side of the steering column.

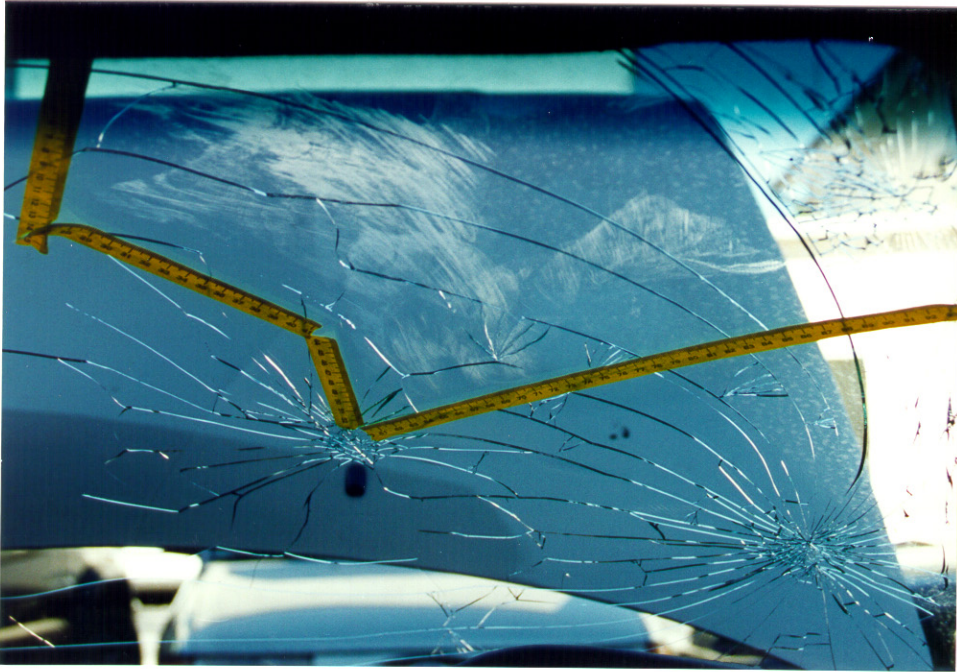
A large white color transfer mark was located on the right side of the windshield between the second and third cracks which extended from mid-level to the windshield header. This was attribute to contact by the passenger side air bag which was deflected by the right front occupant during the air bag expansion cycle.

51. Close-up view of the contact damage on the windshield surface including air bag transfer marks.

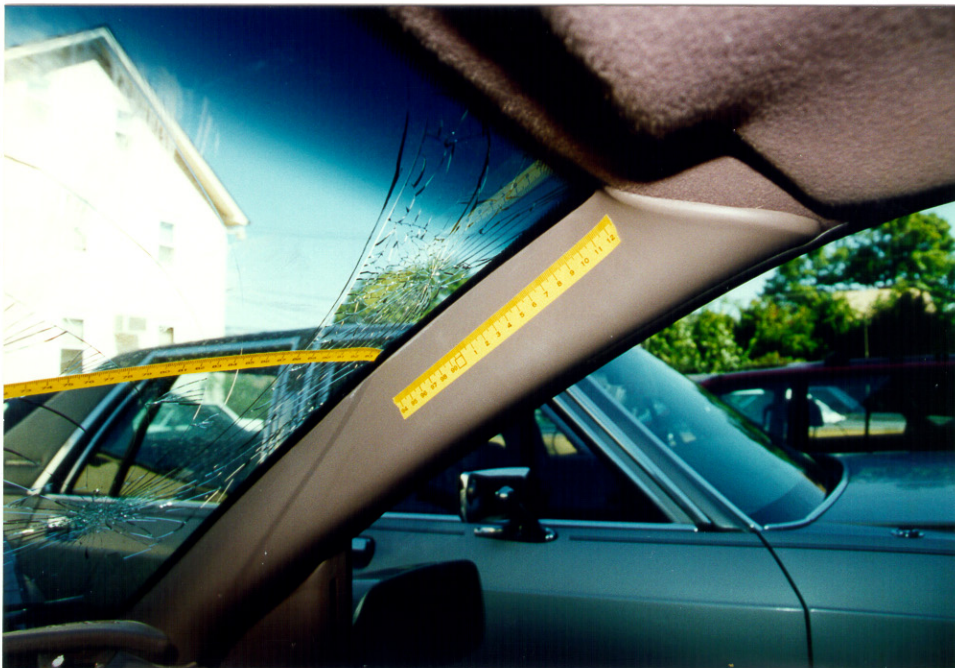
52. View of a scuff mark on the right A-pillar.

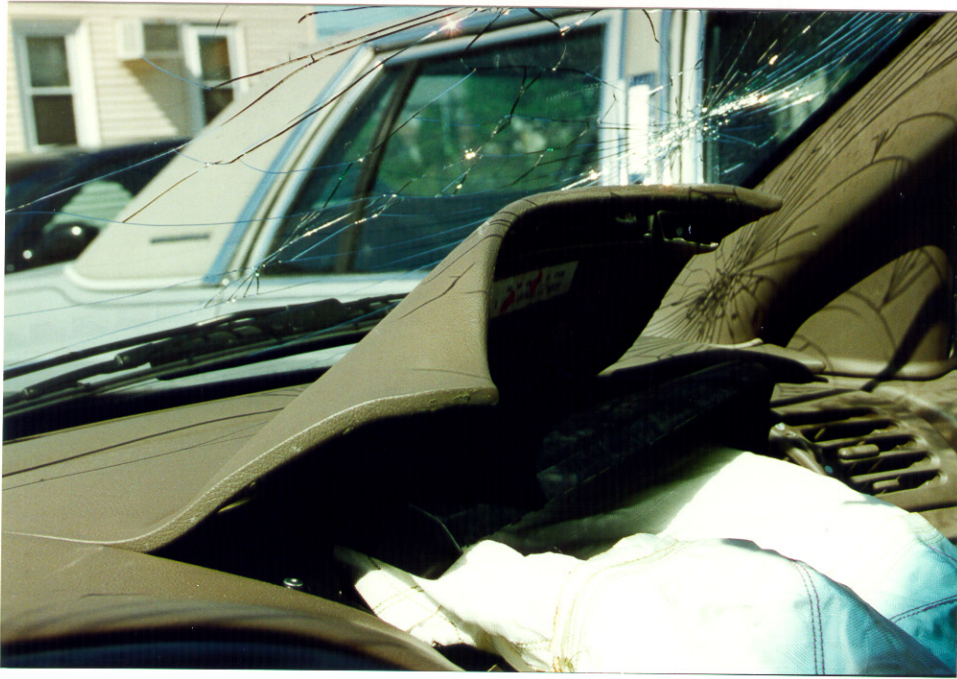
The third windshield fracture had a focal fracture point which resulted from contact by the right bottom corner of the air bag module flap during its upward rotational movement. This fracture was located 44.5 cm (17.5") down from the header and 51.4 cm (20.25") right of center (refer to photographs on pages A-25 thru A-28). The fourth fracture had a similar fracture pattern as the second fracture where there was an absence of a focal loading point. This was located 57.8 cm (22.75") right of the vehicle centerline and 11.4 cm (4.5") below the windshield header and was attributed to contact by the expanding passenger side air bag during its expansion cycle.

55. Lateral view of the air bag module cover flap.

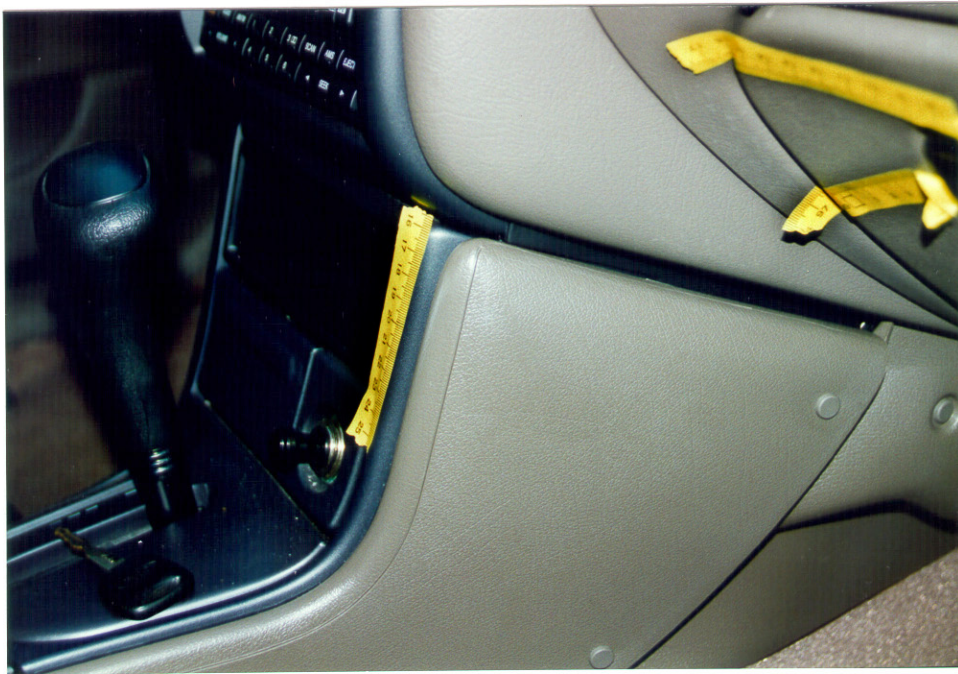
58. Close-up view of the contact marks on the center instrument panel and glove compartment.

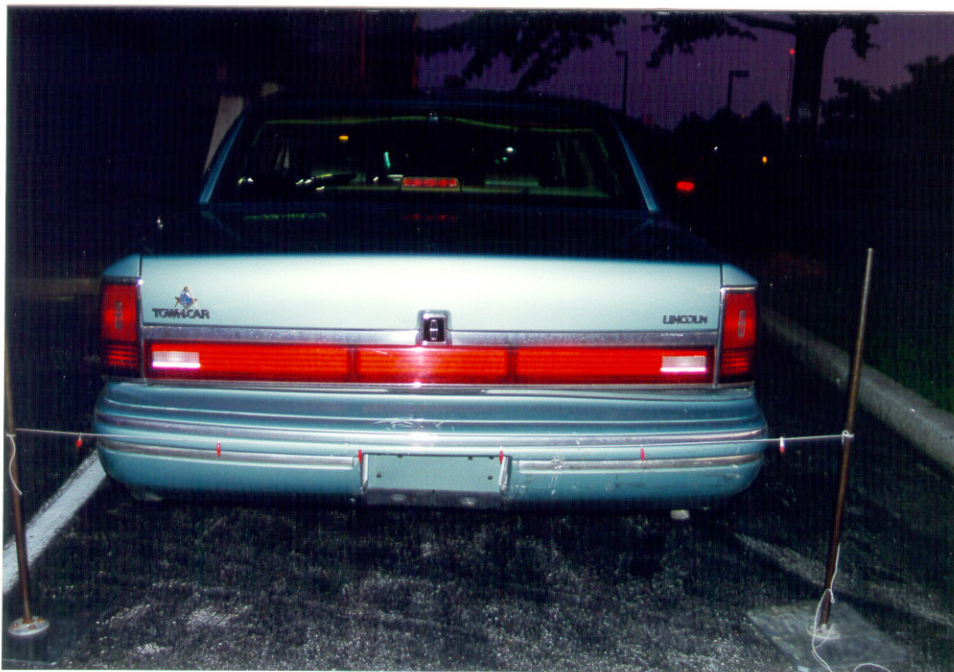
Vehicle #2 sustained minor exterior damage along the rear plane of the vehicle. Direct contact damage began at the right bumper corner and extended 111.8 cm to the left. The maximum crush of 3.8 cm (1.5") was located at the right rear bumper corner. Crush values obtained at the bumper level are listed below:

76. Overhead view of the rear bumper.

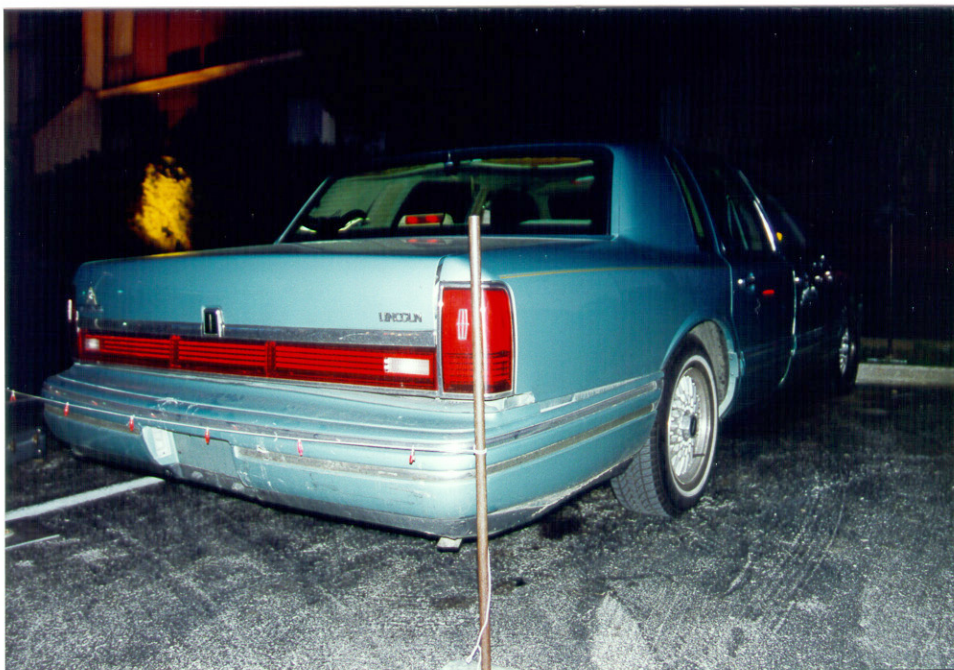
The rear bumper energy absorption devices (EAD) sustained partial compression of 5.1 cm (2.0") on the right side and 3.8 cm (1.5") on the left side with full restitution of both EADs to a measured value of 6.4 cm (2.5"). Damaged components included: the bumper cover, rear trim panel, and trunk lid alignment. Vehicle #1 was driven from the scene by the Driver #2.

77. Rear view of Vehicle #2 showing minimal damage to the bumper area.

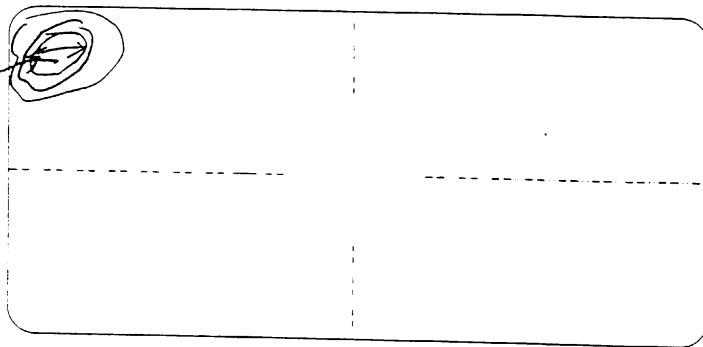
Vent Port
Diameter
9.5 cm
(3.75")
